Walla Walla River Basin Fish Screen Evaluations

Burlingame and Little Walla Walla Sites

**Technical Report
2001**

PNNL-13665

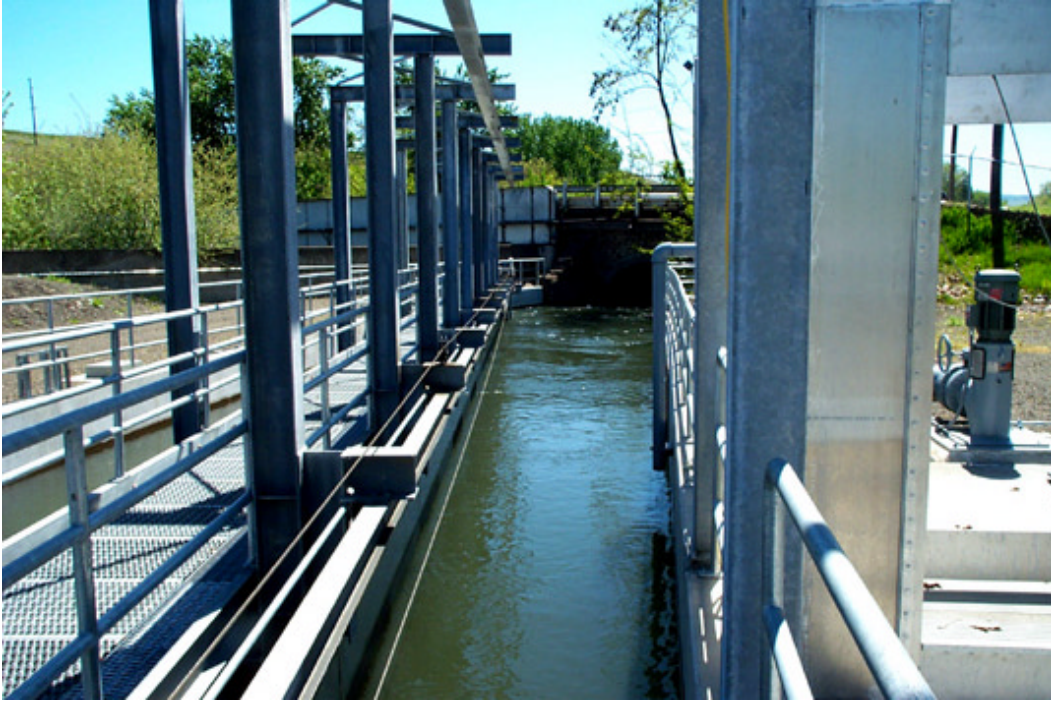
Figure 3. Little Walla Walla fish screen facility.

The Little Walla Walla diversion is located at river mile 47 on the west bank of the Little Walla Walla River, within the city limits of Milton-Freewater, Oregon (Figure 1). The Little Walla Walla site was recently updated by the construction of a set of 11 flat plate screens of stainless steel wedgewire design with 0.069-inch openings, completed in 2000 (Figure 3).

Each screen panel is 9 feet long, 11.75 inches wide and 5 feet tall. The site was designed to accommodate approximately 175 cfs at 80% submergence.
